COMPILATION OF
MATERIALS RESEARCH DATA

Fourth Quarterly Progress Report - Phase I
1 March 1963 to 27 May 1963

SUBJECT: Interpretation of Radiographic Images of Nickel Foil Reinforced Resistance Spot Welds in Type 301 Stainless Steel

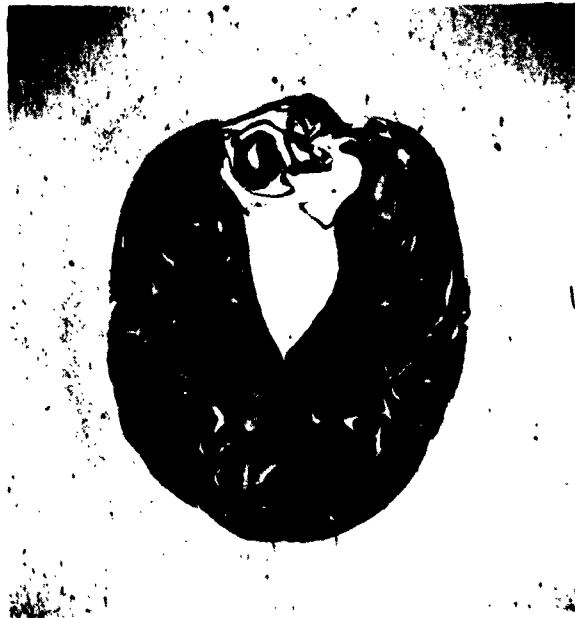
Figure 6. Photomicrograph (30X) of a plan view of spot weld No. 6 shown in Figure 5. This is a view of the weld nugget in its entire shape and represents an intermediate stage between the ring weld and a complete nugget. Note that the X-ray image represented the true outline of the weld nugget.

A "ring" or "dough-nut" weld is shown in Figures 2 and 4 while a heterogeneous weld nugget is shown in Figure 6. This type of nugget is evidently an intermediate step between a ring weld and a completely satisfactory nugget. An example of a complete nugget is shown in the radiograph in Figure 9 and the photomicrograph in Figure 10. It should be observed that no internal image exists in the radiograph of this spot weld.

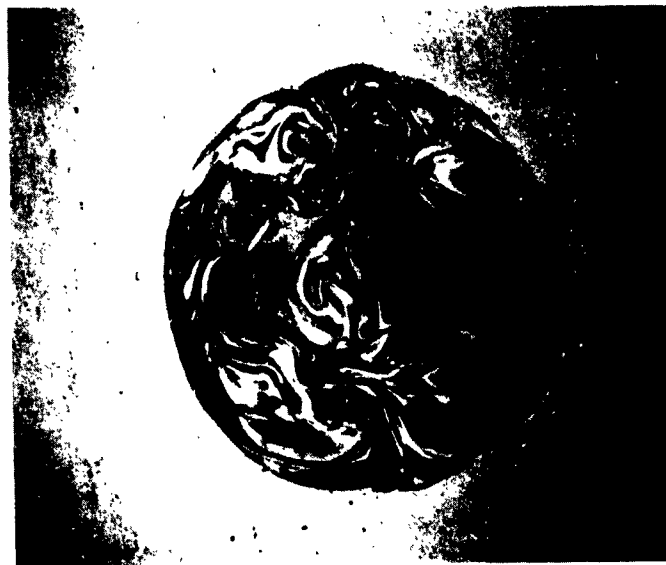
Figure 10. Photomicrograph (30X) of a plan view of the spot weld (No. 3) shown in Figure 9. This spot weld is included to show a typical nickel enriched spot weld with good fusion and the typical "marble-cake" structure.

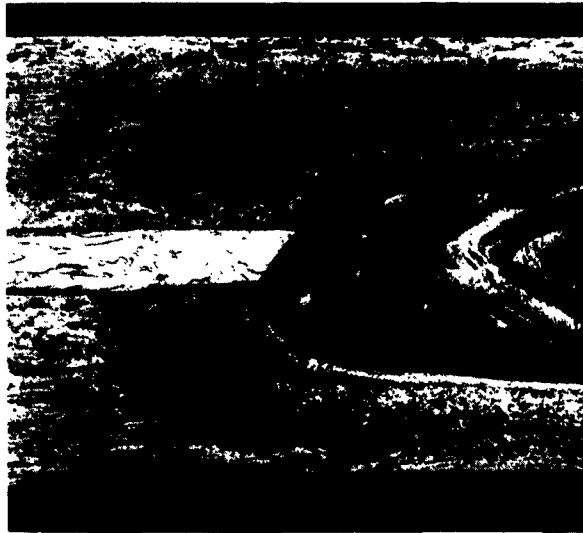
Figure 21. Photomicrograph (100X) of the same view shown in Figure 19 except in the oxalic acid etched condition. When compared to Figure 19, it is apparent that the dark etching line of demarcation, as seen above, is not a crack and, therefore, should not be interpreted as such.

Two spot welds shown in Figures 13 thru 22 were removed from a weld test panel which was never stressed or subjected to cryogenic temperatures. Photomicrographs of the as-polished cross-sections clearly show that no cracks exist at or near the weld nugget. The as-polished sections were also included to answer the question of the black line at the nickel foil and nugget interface of an etched cross-section. This black line has been interpreted as a crack or break in the nickel foil. It will be observed that the dark line on the X-ray image is not caused by a crack, but represents the interface between two different metal phases. Since these spot welds are completely fused (not of the ring, horseshoe, or puckered type), it is believed that radiography is again detecting the outline of the nugget by means of the dark, peripheral line image.

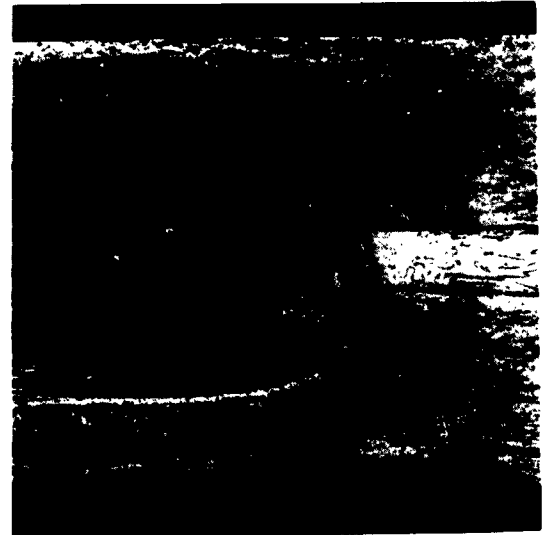
Figure 22. Photomicrograph (100X) of the same view shown in Figure 20 except in the oxalic acid etched condition. The same comments in respect to the dark etching line also apply to this section.
